Contract #: 04-0120F4Cty: SF/ALA Rte: 80 PM: 13.2/13.9File #: 99.28**WELDING INSPECTION REPORT****Resident Engineer:**Siegenthaler, Peter**Address:** 333 Burma Road**City:** Oakland, CA 94607**Report No:** WIR-023691**Date Inspected:** 12-May-2011**Project Name:** SAS Superstructure**OSM Arrival Time:** 700**Prime Contractor:** American Bridge/Fluor Enterprises, a JV**OSM Departure Time:** 1900**Contractor:** Zhenhua Port Machinery Company, Ltd (ZPMC) Chanxing Island**Location:** Shanghai, China**CWI Name:** Mr. Sun Tian Liang**CWI Present:** Yes No**Inspected CWI report:** Yes No N/A**Rod Oven in Use:** Yes No N/A**Electrode to specification:** Yes No N/A**Weld Procedures Followed:** Yes No N/A**Qualified Welders:** Yes No N/A**Verified Joint Fit-up:** Yes No N/A**Approved Drawings:** Yes No N/A**Approved WPS:** Yes No N/A**Delayed / Cancelled:** Yes No N/A**Bridge No:** 34-0006**Component:** OBG Segment**Summary of Items Observed:**

OBG Trail Assembly

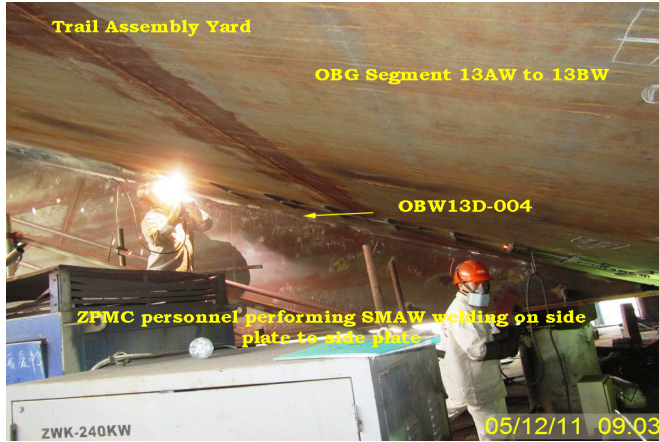
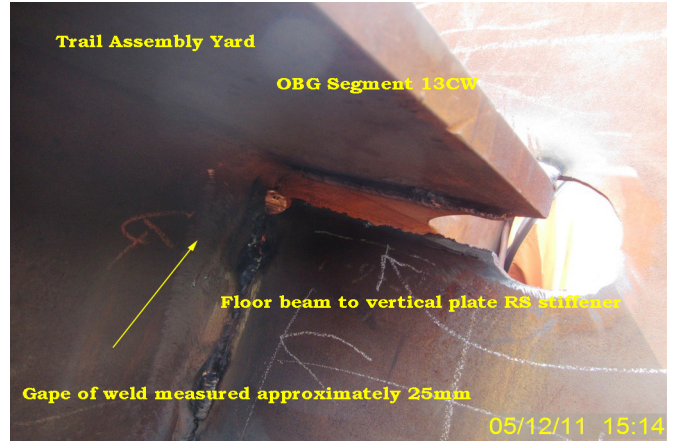
Description of Incident: During random Quality Assurance Visual in-process inspection of welds located on segment 13CW, this Quality Assurance Inspector (QA) observed that ZPMC personnel performed flame cutting on floor beam to deck panel diaphragm weld at Counter Weight Side. Prior to weld cutting ZPMC QC informed to inspection engineer. The floor Beam number is identified as FB3237A and the panel point is identified as 124.5. This weld is a Fillet weld joining the Floor beam Web to Deck panel diaphragm. The gape of this weld measured approximately 25mm. So ZPMC has to be converted fillet weld to CJP weld and the Floor Beam Flange weld is identified as Non SPCM. For further information, please see the attached pictures.
